FORENSIC PROCESSES FOR WATER INTRUSION INVESTIGATIONS

Case Study

By Lonnie Haughton, CDT

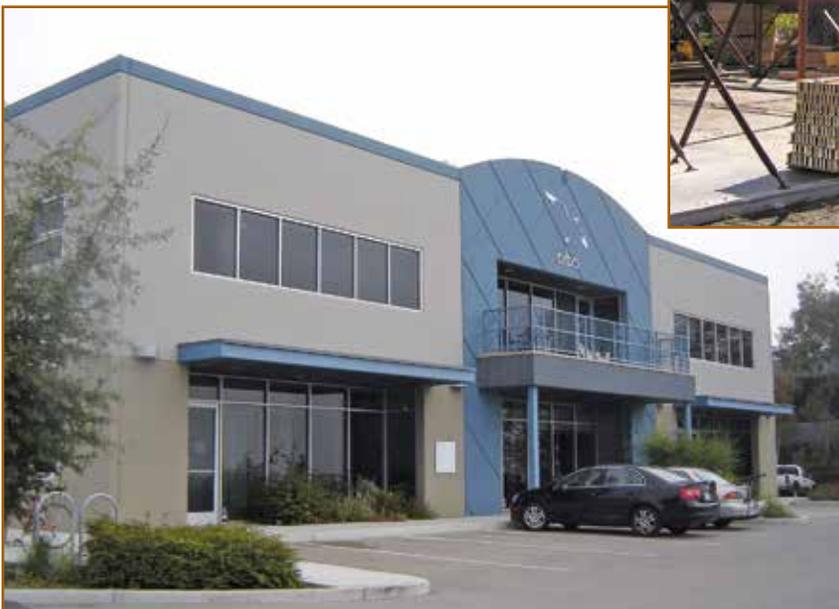
Photo 1 – Nonprofit research facility near San Francisco.

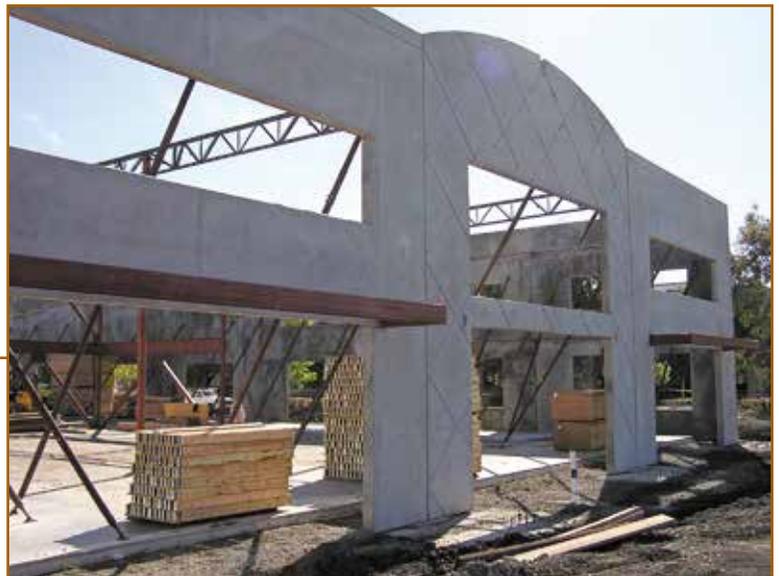
Photo 2 – 2005: Concrete tilt-up panels on “spread footings” surround on-grade concrete slab.

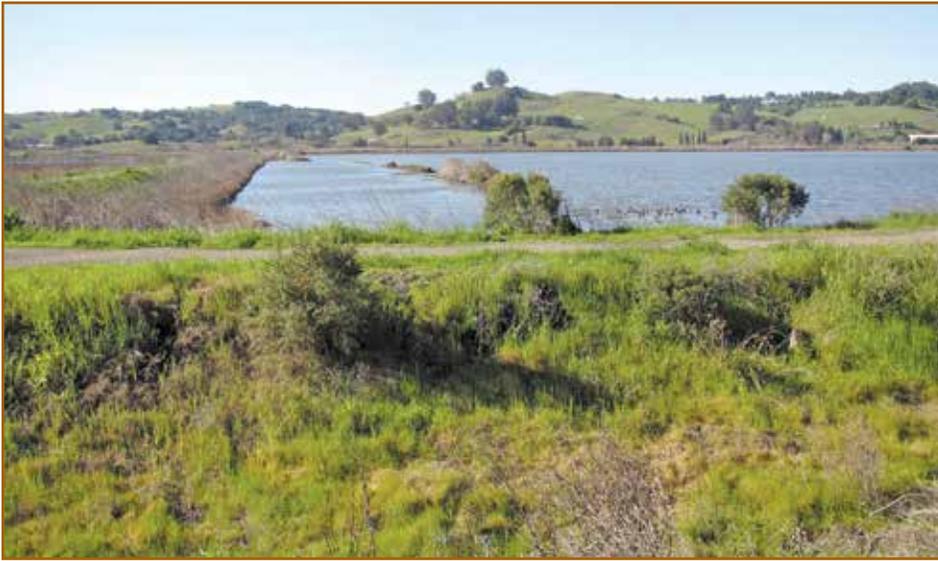
Photo 3 – The building was constructed atop a high water table adjacent to a tidal estuary.

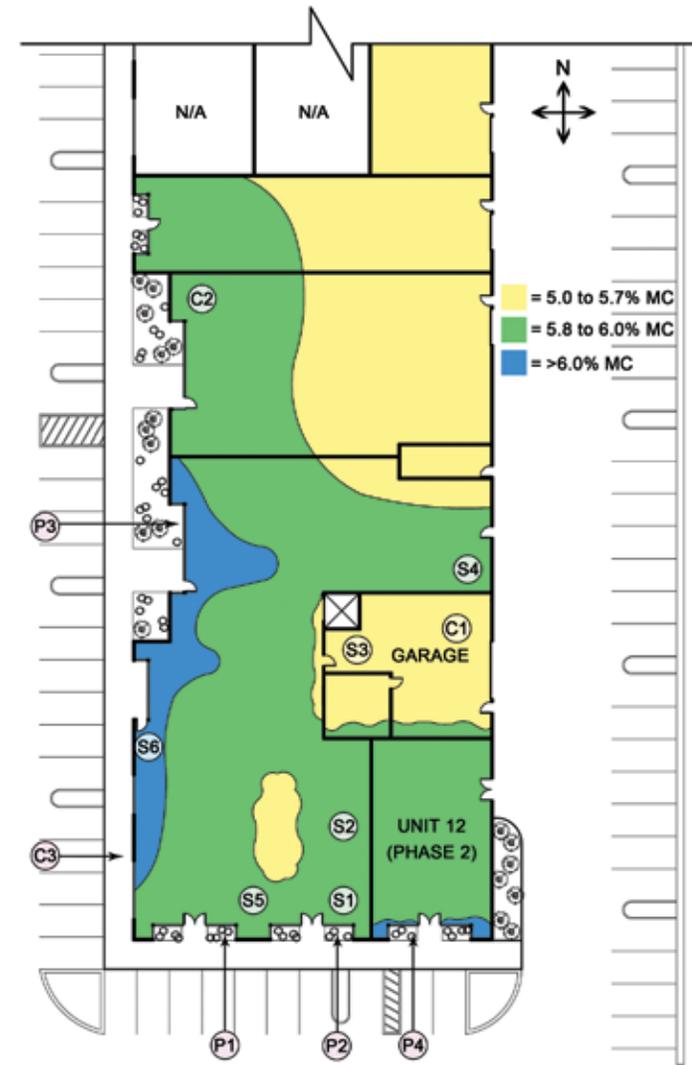
In *Figure 1*, which presents a floor plan of the building, our preliminary (Phase 1) and later (Phase 2) electrical impedance metering is summarized in three approximate zones of moisture content: “yellow” (5.0 to 5.7%), “green” (5.8 to 6.0%), and “blue” (>6.0%). The Phase 1 data suggested that primary origin(s) of the unintended moisture infiltration might be located at or near the western edge of the slab.⁹

Figure 1 – Partial plan view identifies the “internal RH” sensors (S), the concrete test cuts (C), four inspected planters (P), and approximate moisture content (MC) measurements at the concrete slab.

Meanwhile, we had received permission to take moisture content readings of the concrete floor slab inside south-facing Unit 12 (see Photo 14), which had become vacant. As shown in Figure 1, the entire floor in Unit 12 was found to be very wet, with the wettest readings at the southern edge adjacent to the planters.

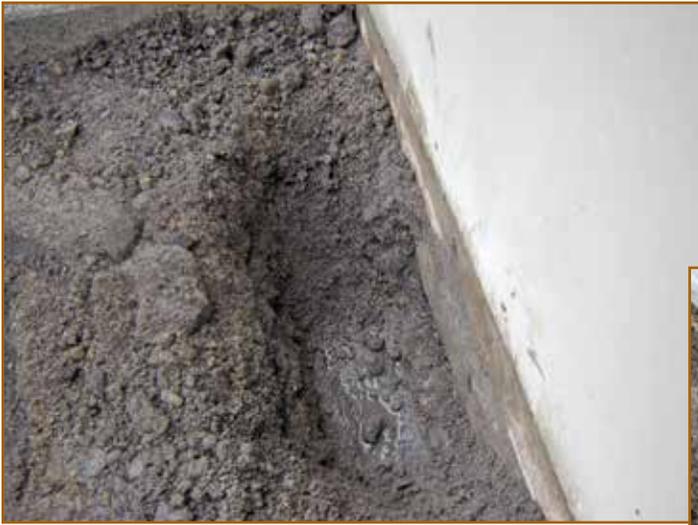
tilt-up panel, indicating the existence of a pool of water under the slab at its western perimeter.

Photo 10 – Test cut C-3 at sidewalk: Water began seeping outward from under the concrete tilt-up panel.

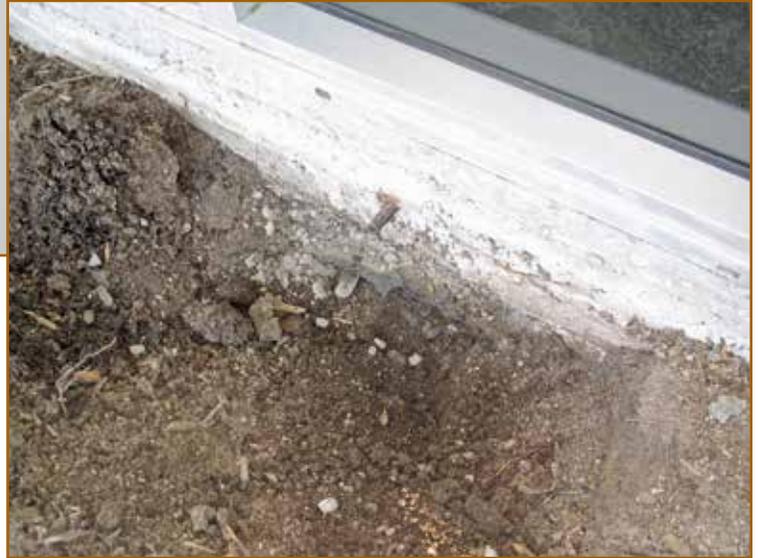
Upon digging into planters P-1 and P-2 (see Figure 1) between the front of the building and the sidewalk, we found corroded rebar and the exposed edge of a blackish 10-mil polyethylene vapor retarder (also punctured). In other words, as seen in Photo 11, the contractor had not closed off (or “turned down”) the edge of the concrete slab to provide a water migration barrier between the planter soil and the granular base and subbase under the concrete slab. However, within these two planters, we found no evidence of ponding or trapped water, and we observed that the granular fill supporting the sidewalk promoted good

Photo 11 – Soil in planter directly abuts the granular subgrade under the concrete slab. The punctured polyethylene vapor retarder is visible under the corroded rebar.

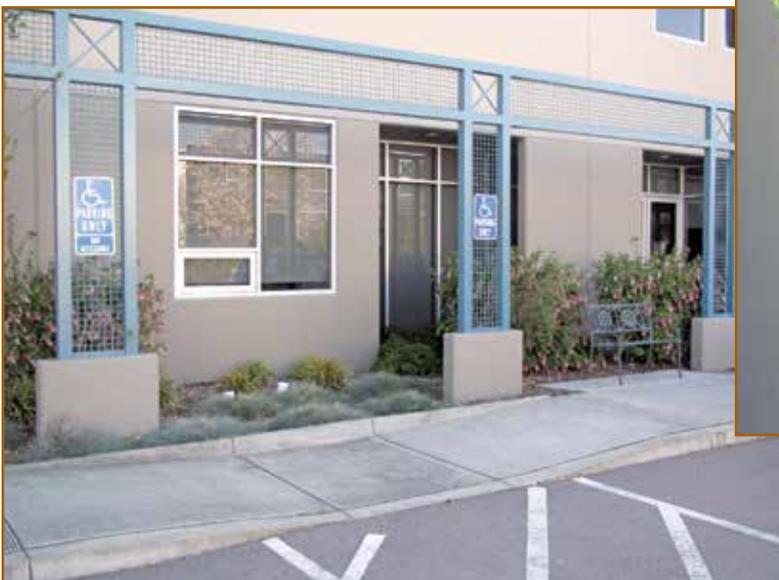
Photo 12 – Overview of P-3 planter.

Finally, even though our excavation at the P-1 and P-2 planters at the front of the building had revealed a drainable granular base under the adjacent sidewalk, here at the P-3 sidewalk, we found native clay soil that was highly sticky and water-saturated, providing minimal drainage, if any, from the planter. In short, at the four sides of the P-3 planter, only the granular base and subbase under the slab provided drainage routes.

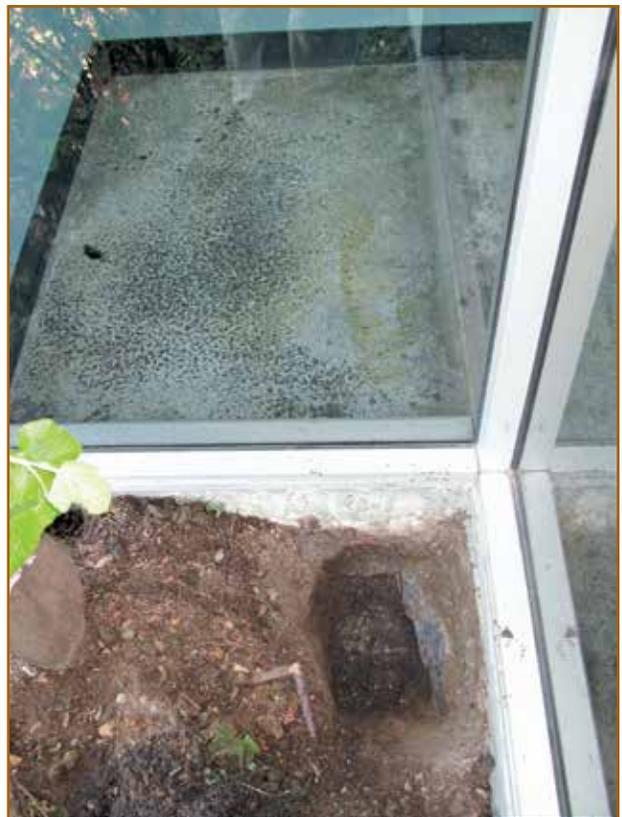
We excavated into the P-4 planter (Photo 15), again finding wet soil, the exposed edge of the polyethylene vapor retarder, and visual evidence that water migration under the concrete slab was occurring atop the LTS pad, which was found to have an undulated surface that could pond water. Then, under the P-4

sidewalk, we again found native clay soil that was highly sticky and water-saturated, providing minimal drainage, if any, from the planter. (Also note the plastic piping for the landscaping irrigation in Photo 15.)

Photo 15 – The pour strip (or pour-back strip)²¹ within Unit 12 was saturated. The planter drains under the slab via the LTS pad.
