# The Four D's

## Integrating the D's in Building Envelope Design

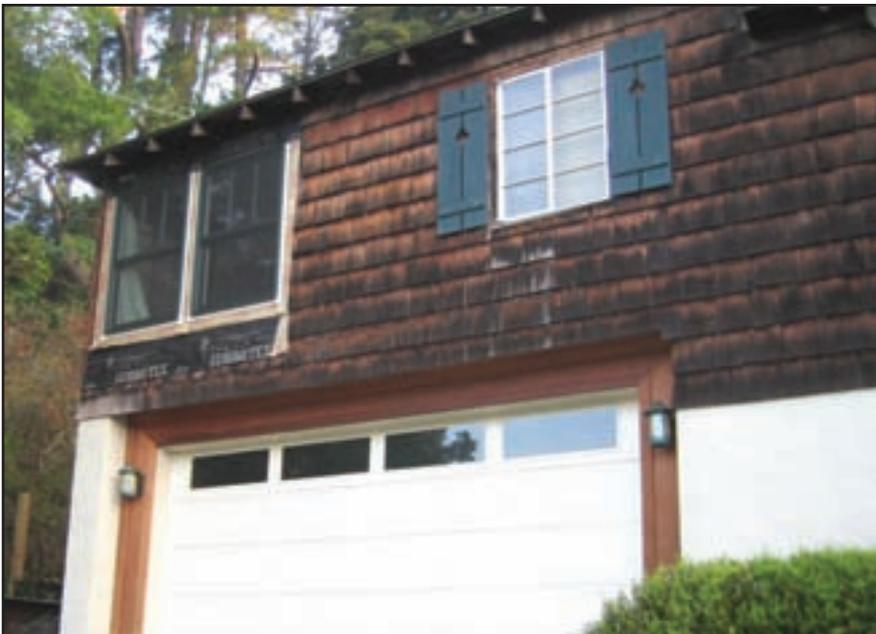
The owner is replacing the original aluminum windows (above right) with new metal-clad wood windows (above left). Note the severe deterioration in the redwood shakes.

The owner is replacing the original small single-paned aluminum casement windows with larger double-paned, double-hung windows (*photo at left*). The severe deterioration of the original old-growth redwood shakes required total replacement at this weather-exposed elevation. It also is important to note that, while the redwood shakes had been attached to one layer of #30 felt, no effort had been made to flash the original aluminum windows.

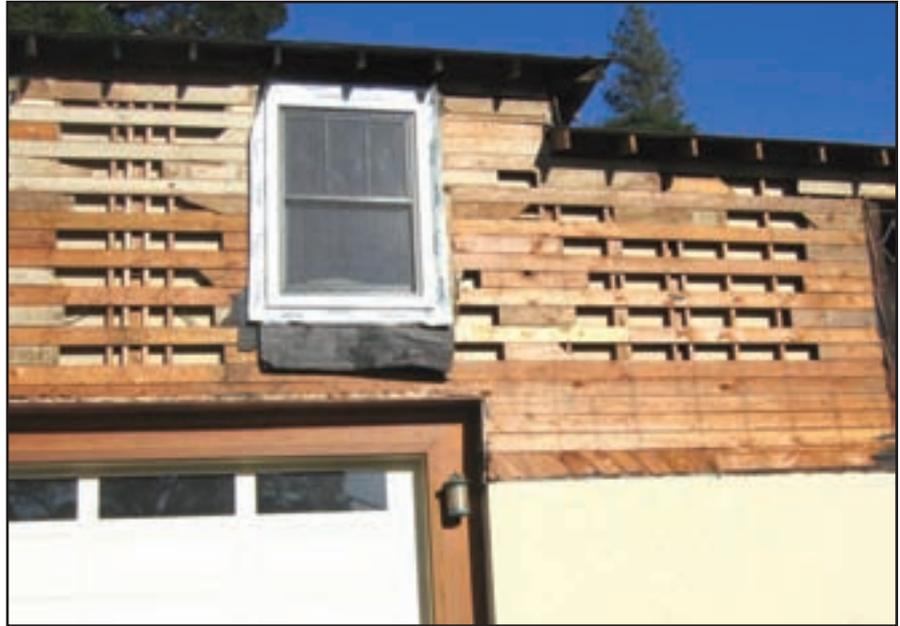
**Removal of the deteriorated redwood shakes reveals no water damage at the wood board sheathing or stud framing.**

However, in the photo to the right, we see that, despite the extensive decay of the redwood shakes, there is absolutely no water damage at the wood sheathing or framing. To understand this phenomenon, we need to evaluate the four D's of the original wall design:

- **Deflection:** the relatively small roof overhang provided only a fair degree of rainfall deflection.
- **Drainage:** the failure to install a gutter at the roof and the lack of any flashing at the original windows represents poor drainage performance.

- **Drying:** the exterior wall has no insulation, no interior vapor retarder and numerous open spaces between the wood sheathing boards. As a result, the design provides excellent drying performance from both the interior (during wet winter months) and the exterior (during the dry summer season).

- **Durability:** the old-growth redwood shakes exhibited good durability, as evidenced by their overall survival for more than 50 years in a wet climate below a gutter-less roof. In addition, the heavily built window frames, which were manufactured in the post-World War II era when aluminum was plentiful and cheap, continued to provide exceptional durability.

Despite poor drainage and only fair deflection properties, the assembly provided more than 50 years of complete weather-resistive performance primarily because of continual drying at the back side of the durable redwood shakes that covered the wall.
